## Sunnyside Cogeneration Associates

RE: Annual 2005 Inspection Report  
Sunnyside Refuse and Slurry C/007/035

Please find enclosed a copy of the Annual 2005 Inspection Report for the Sunnyside refuse pile, impoundments, and excess spoil areas. The inspection was performed by a professional engineer from Psomas and Associates Engineering.

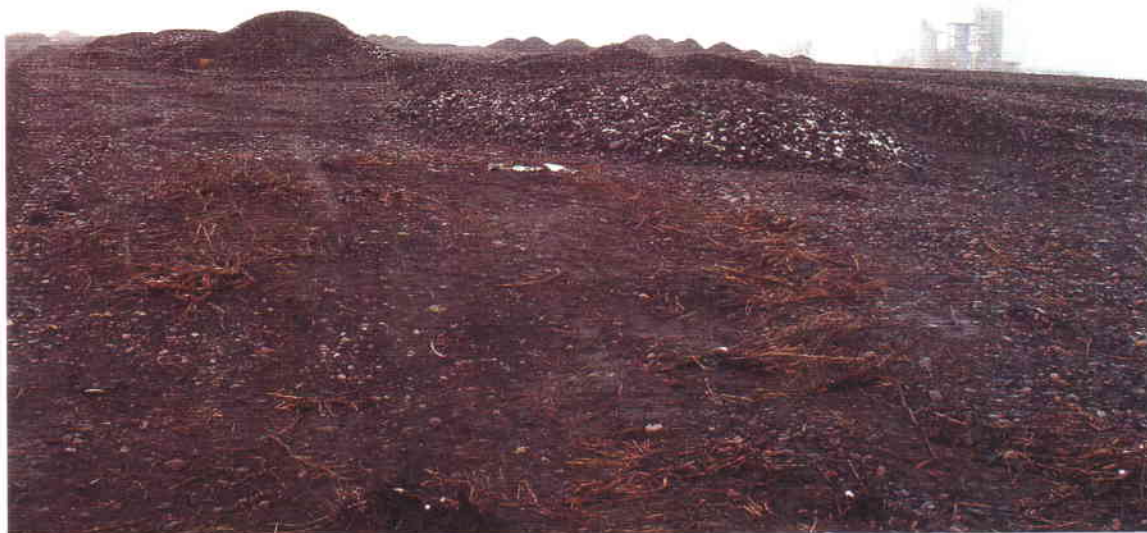
Excess Spoil Disposal Area #2 Looking South

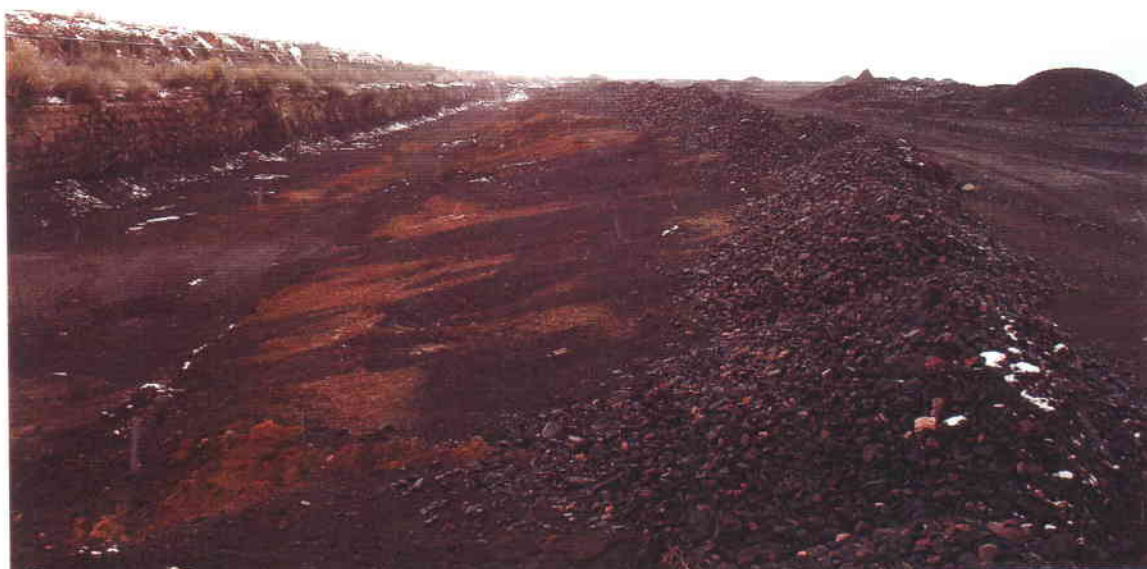
Excess Spoil Area #2 Looking south along the old slurry ditch

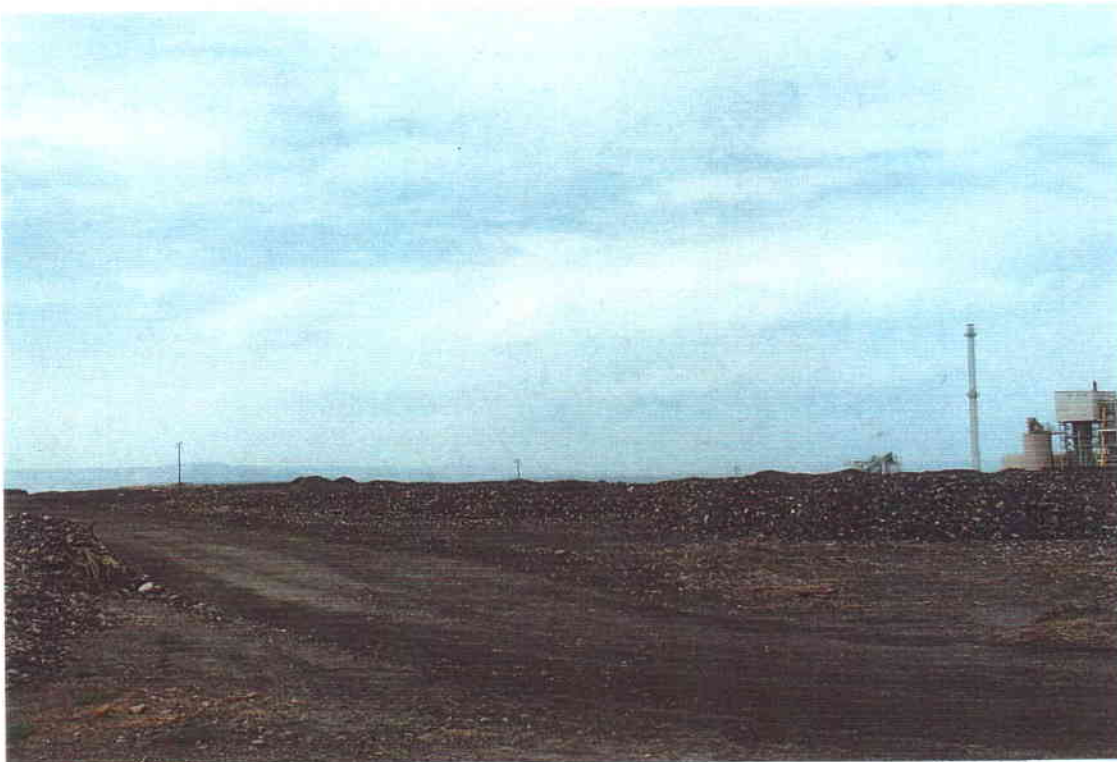
Excess Spoil Disposal Area #2 looking south

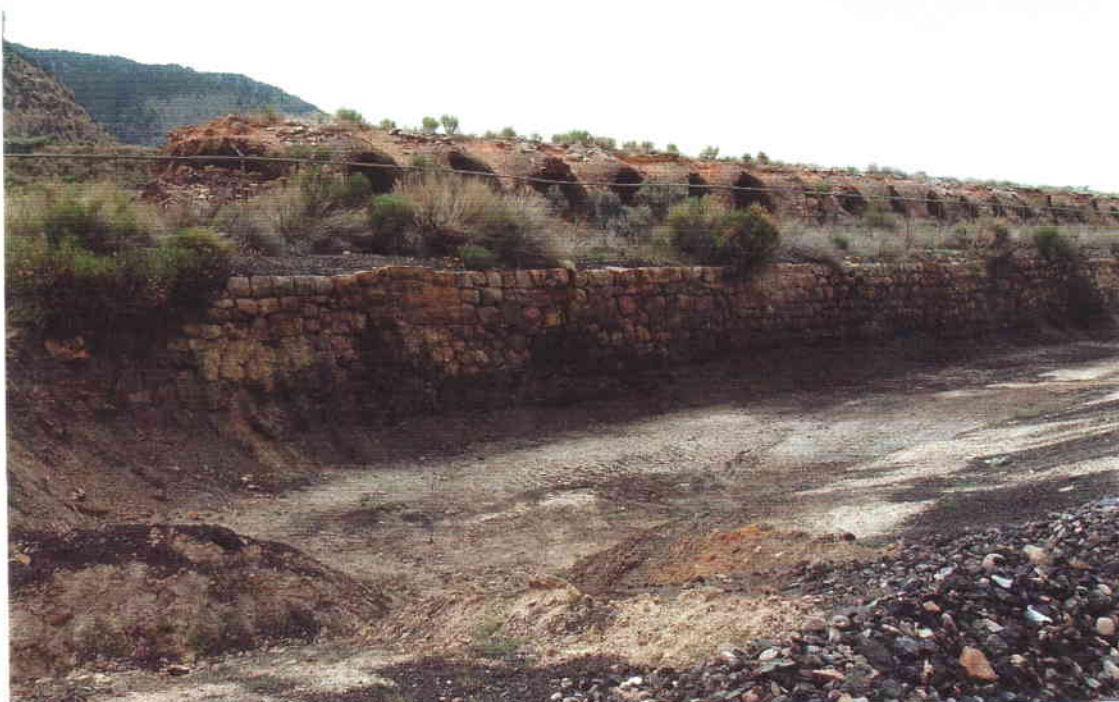
Exposed Wall along east side of Excess Spoil Disposal Area #2

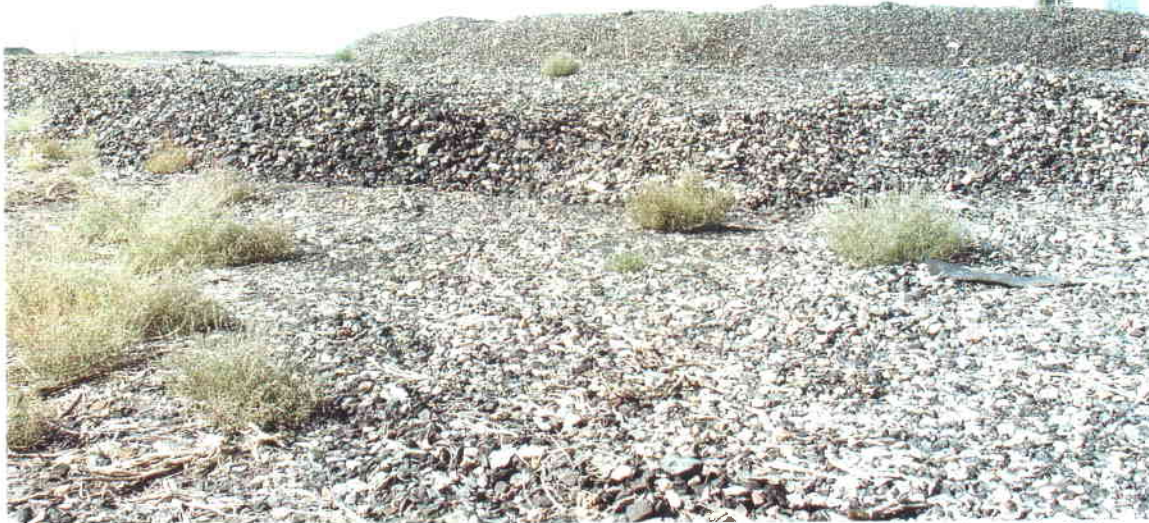
Excess Spoil Disposal Area #2 North End looking westerly September 20, 2005

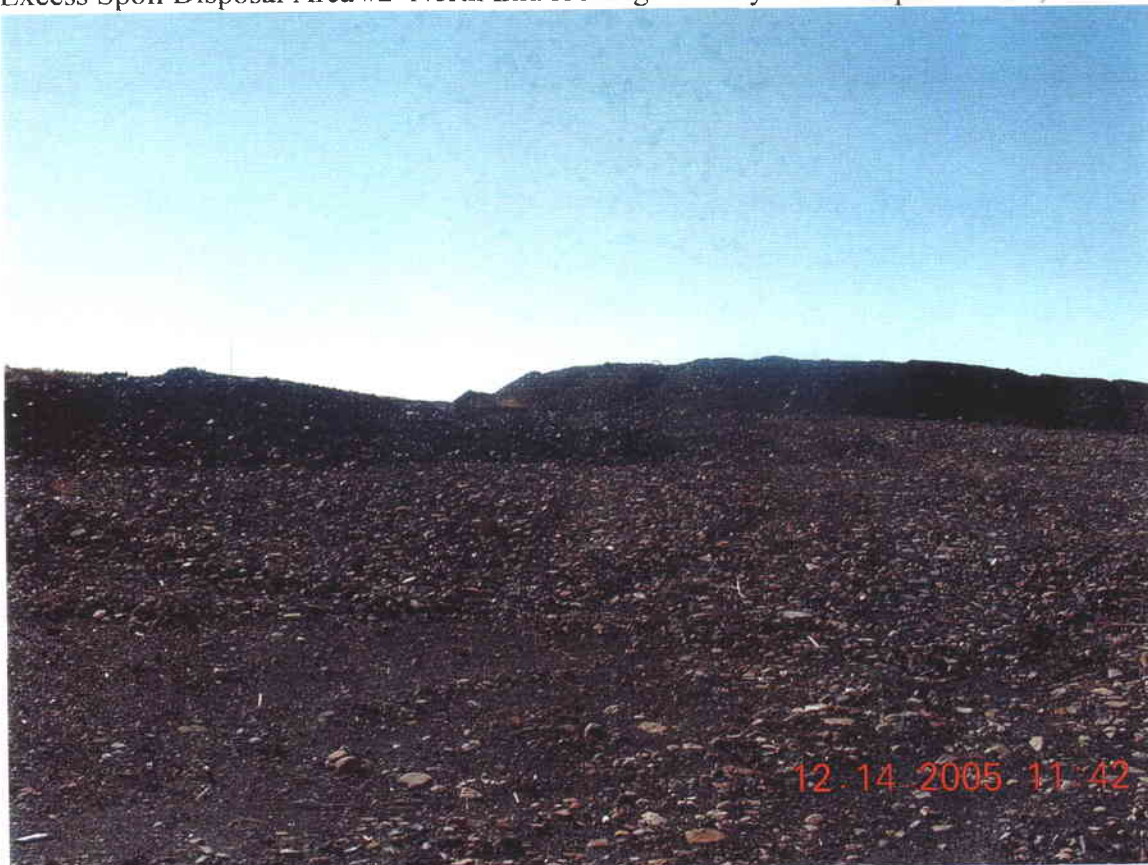
Excess Spoil Disposal Area #2 North End looking westerly Dec 14, 2005
